The Analysis of Silver Depletion on Stainless Steel for Potable Water System

Marcela Strane, Environmental Engineering
Mentor: Dr. Francois Perreault

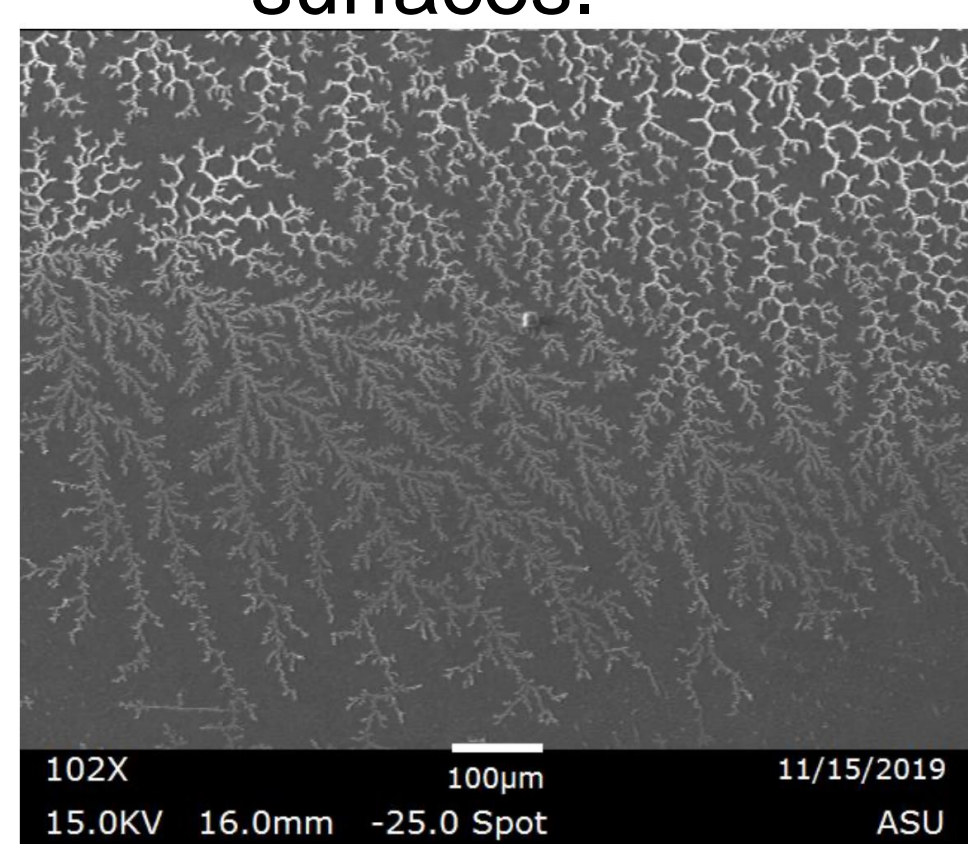
Figure 2: NBH₄ and 10⁻¹ M Na₂S coated on steel 444 pattern

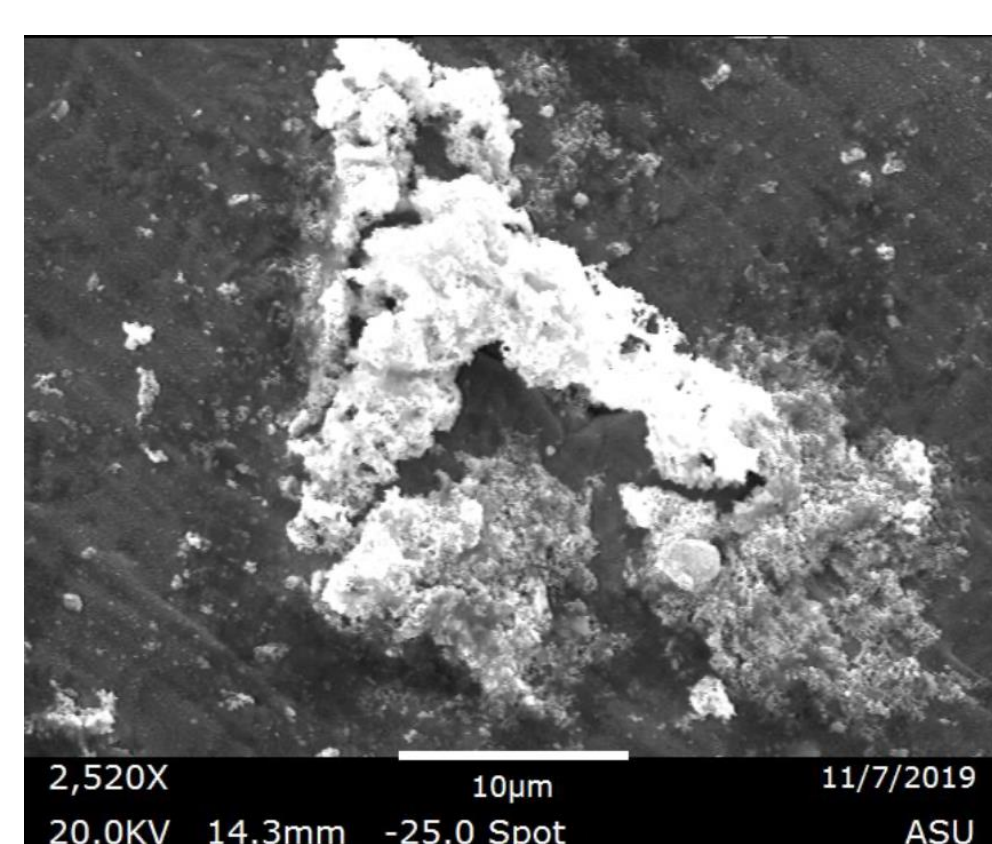
Figure 3: AgNPs agglomerating on 10⁻¹ M Na₂S SS

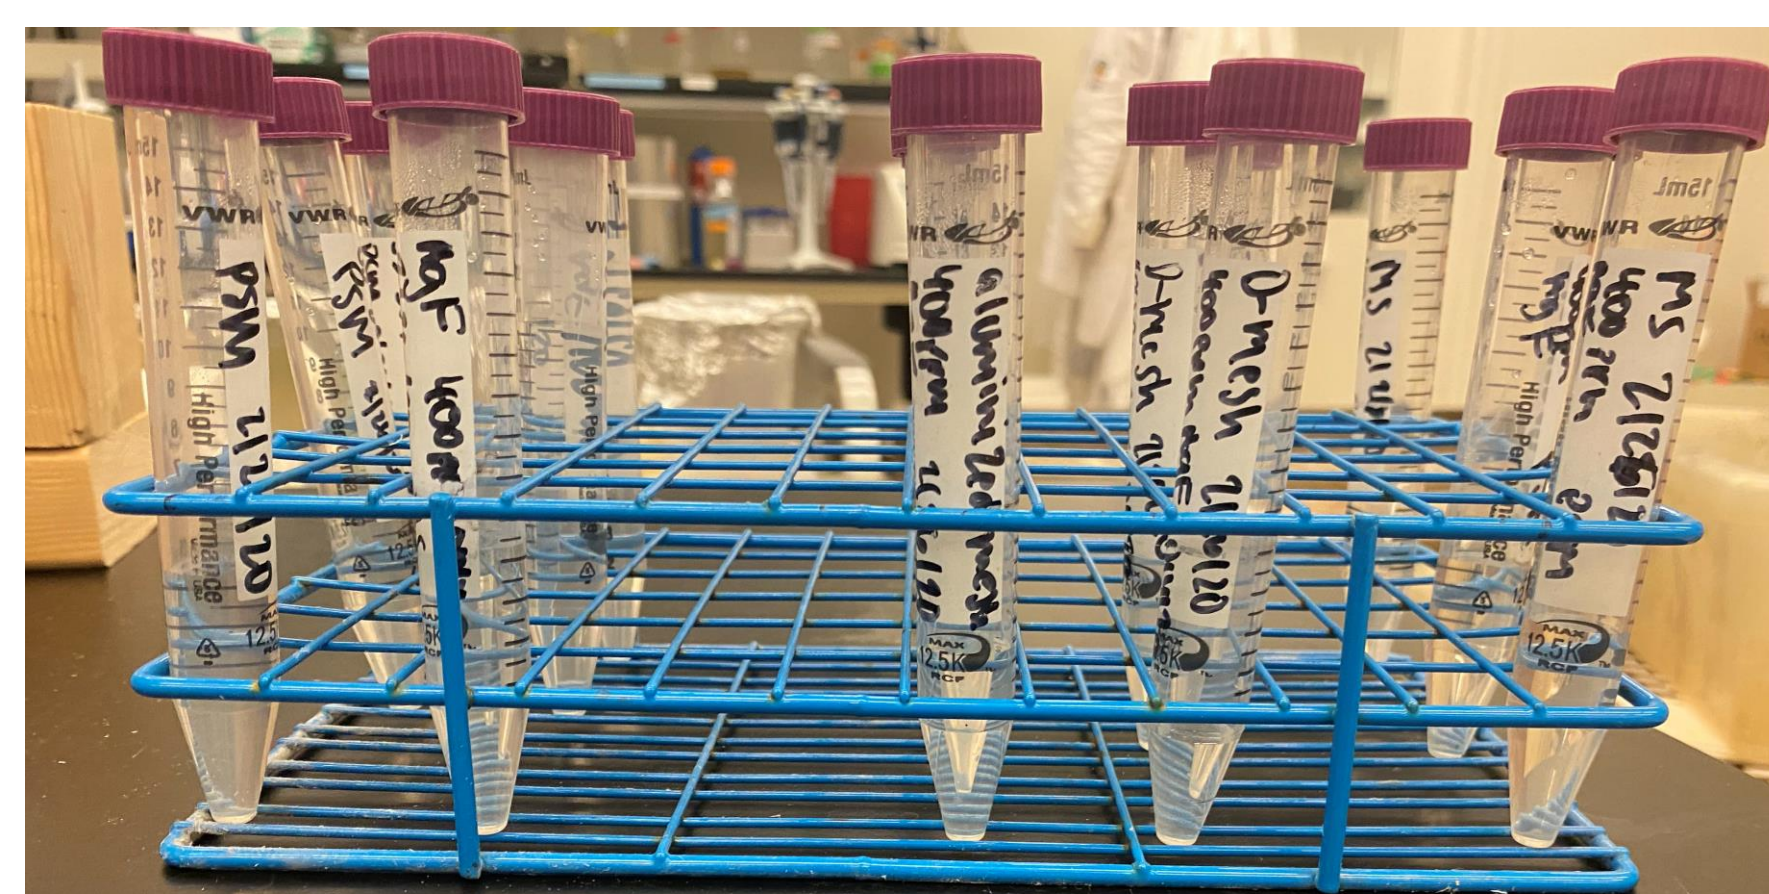
Figure 5: coupons in AgF solution to be agitated for 7 days

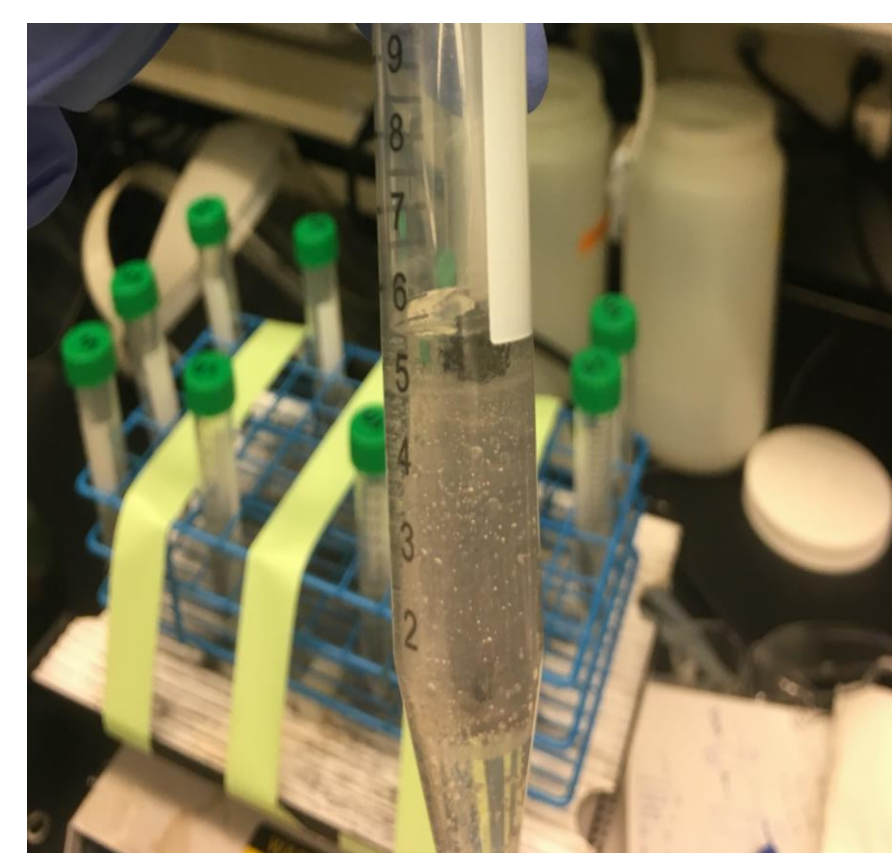
Figure 6: Close up of silver and NBH cluster from mixing after coating coupons

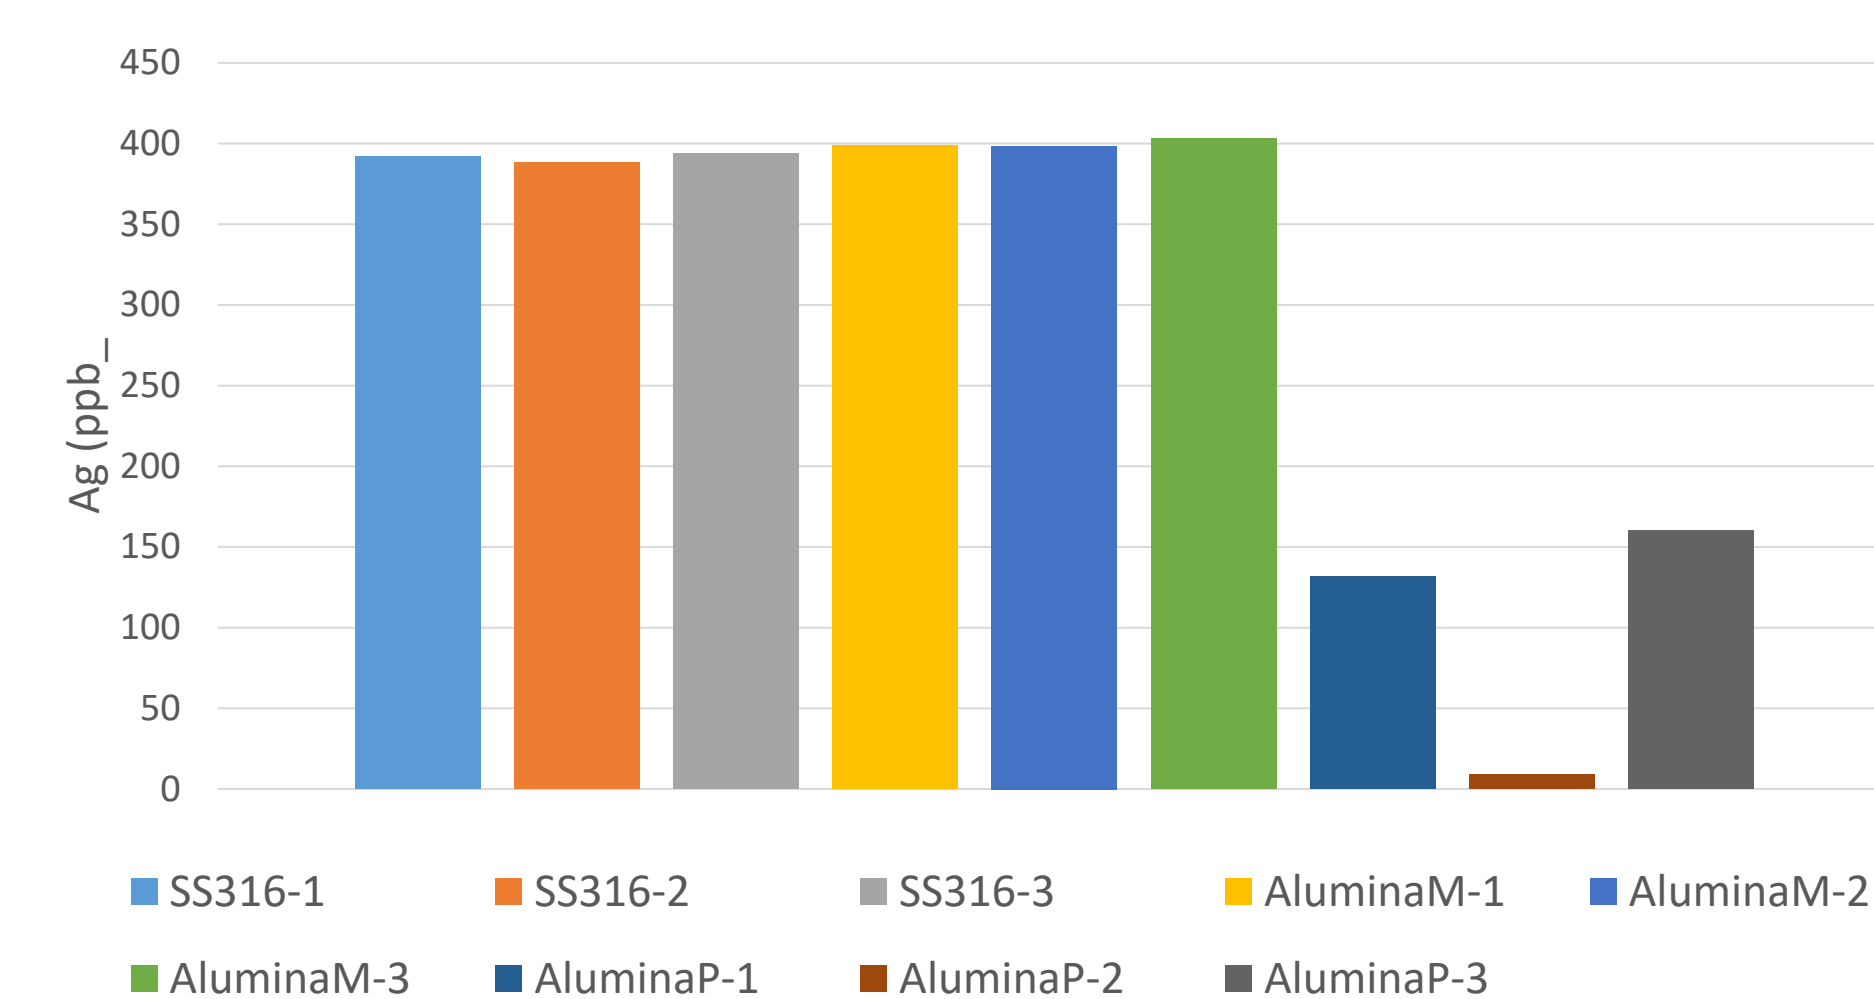
[Ag] Averages after 7 days

- AluminaP samples show significant amounts of loss of silver
- SS316, even though not treated show little loss of silver compared to previous work conducted
- For AluminaM samples, little to no silver sticks onto the coupon surface

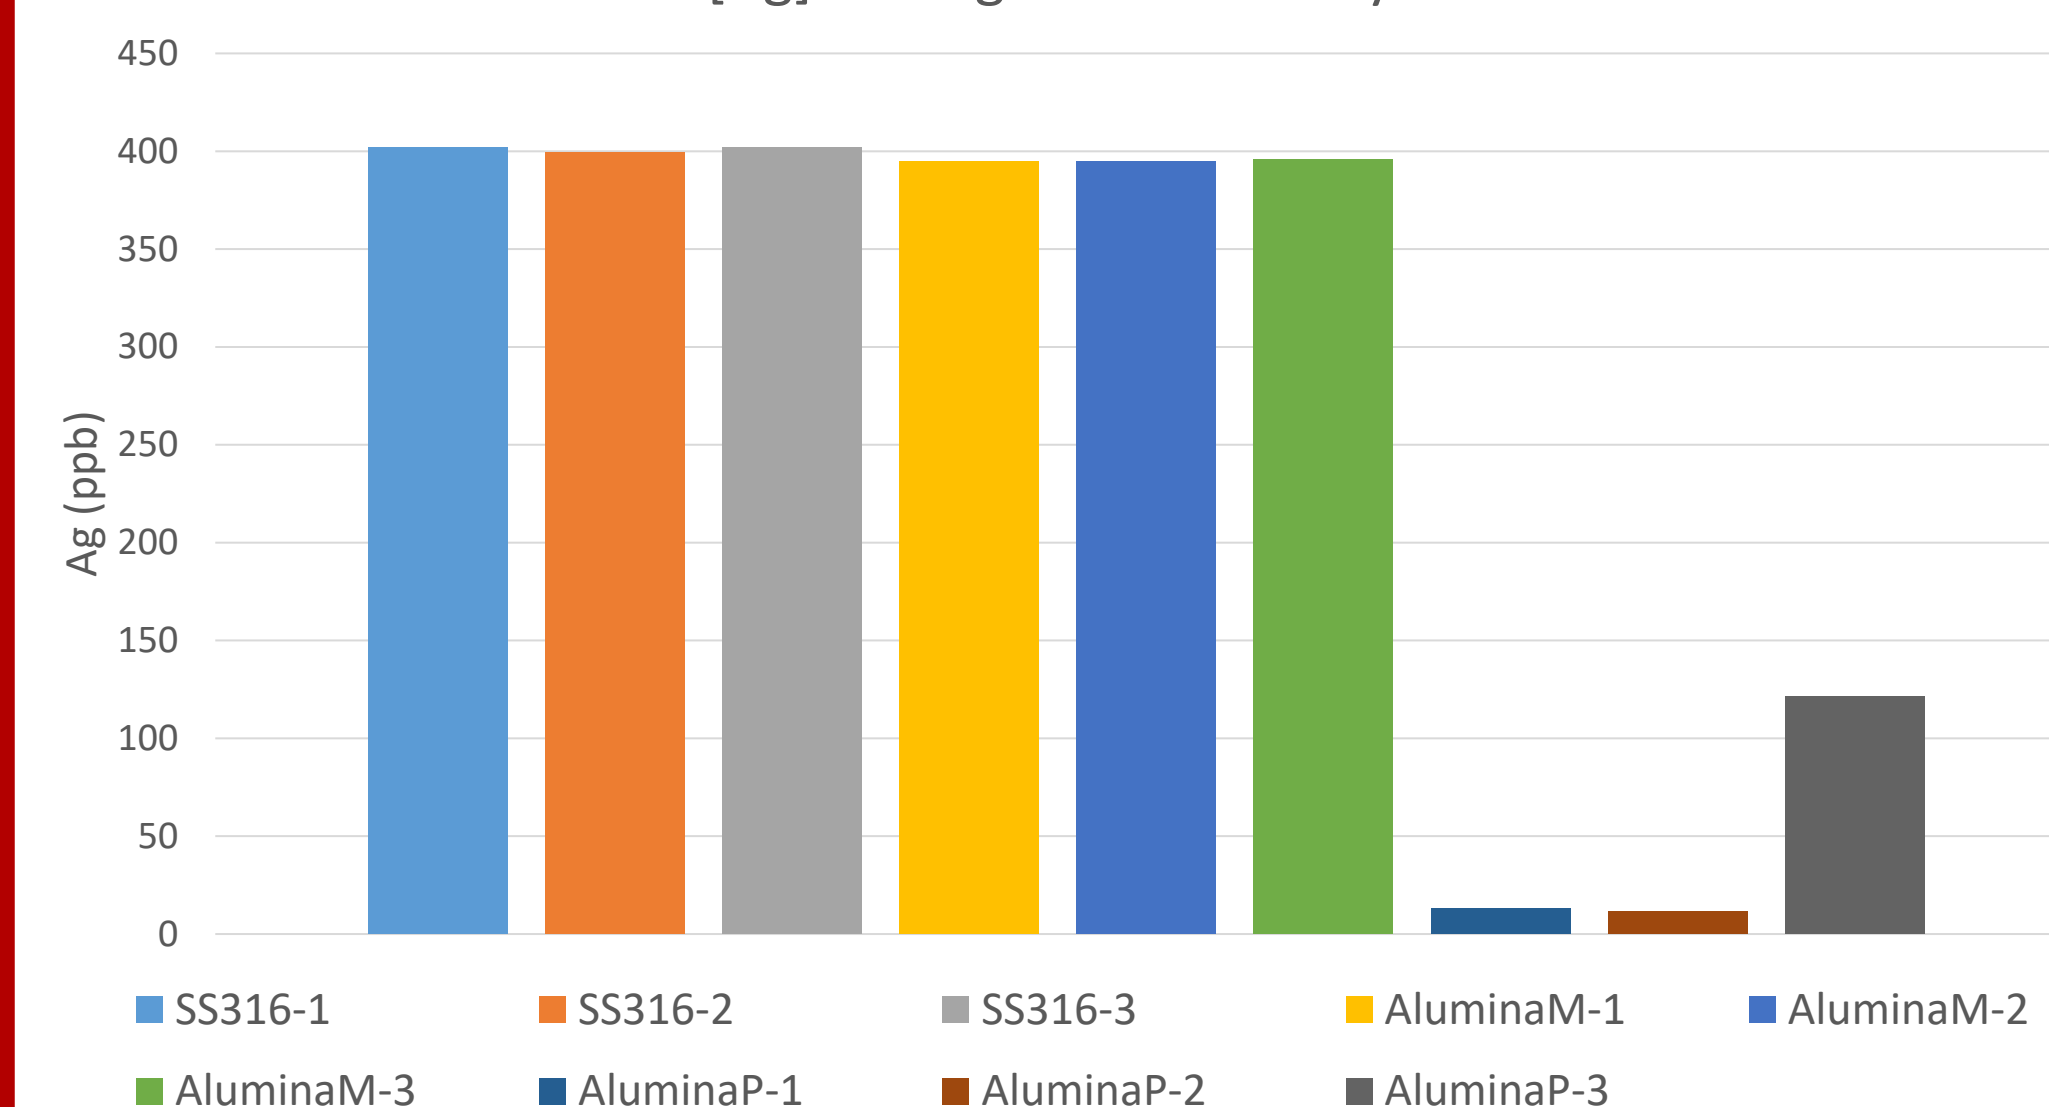
[Ag] Averages After 14 days

- At 14 days, there are similar results to the 7-day averages
- AluminaP samples again show significant amounts of loss of silver
- AluminaM samples show almost no loss of silver after agitation
