Phosphorus Accumulation in the Gilbert Riparian Preserve Aquifer Recharge Ponds

Suraya Sidique, Environmental Engineering
Mentor: Dr. Rebecca Muenich, Assistant Professor
School of Sustainable Engineering and the Built Environment

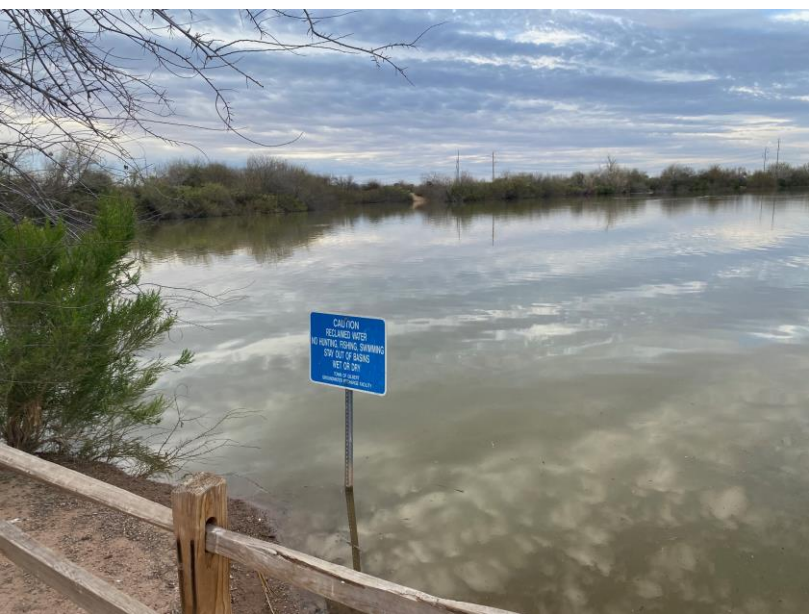
Fig. 1 North side of pond 7

The objective of this project was to quantify the phosphorus budget of an aquifer recharge infiltration pond at the Gilbert Riparian Preserve and determine if those levels are cause for concern. These ponds are recharged with treated wastewater effluent from the City of Gilbert, and therefore contain elevated levels of phosphorus.

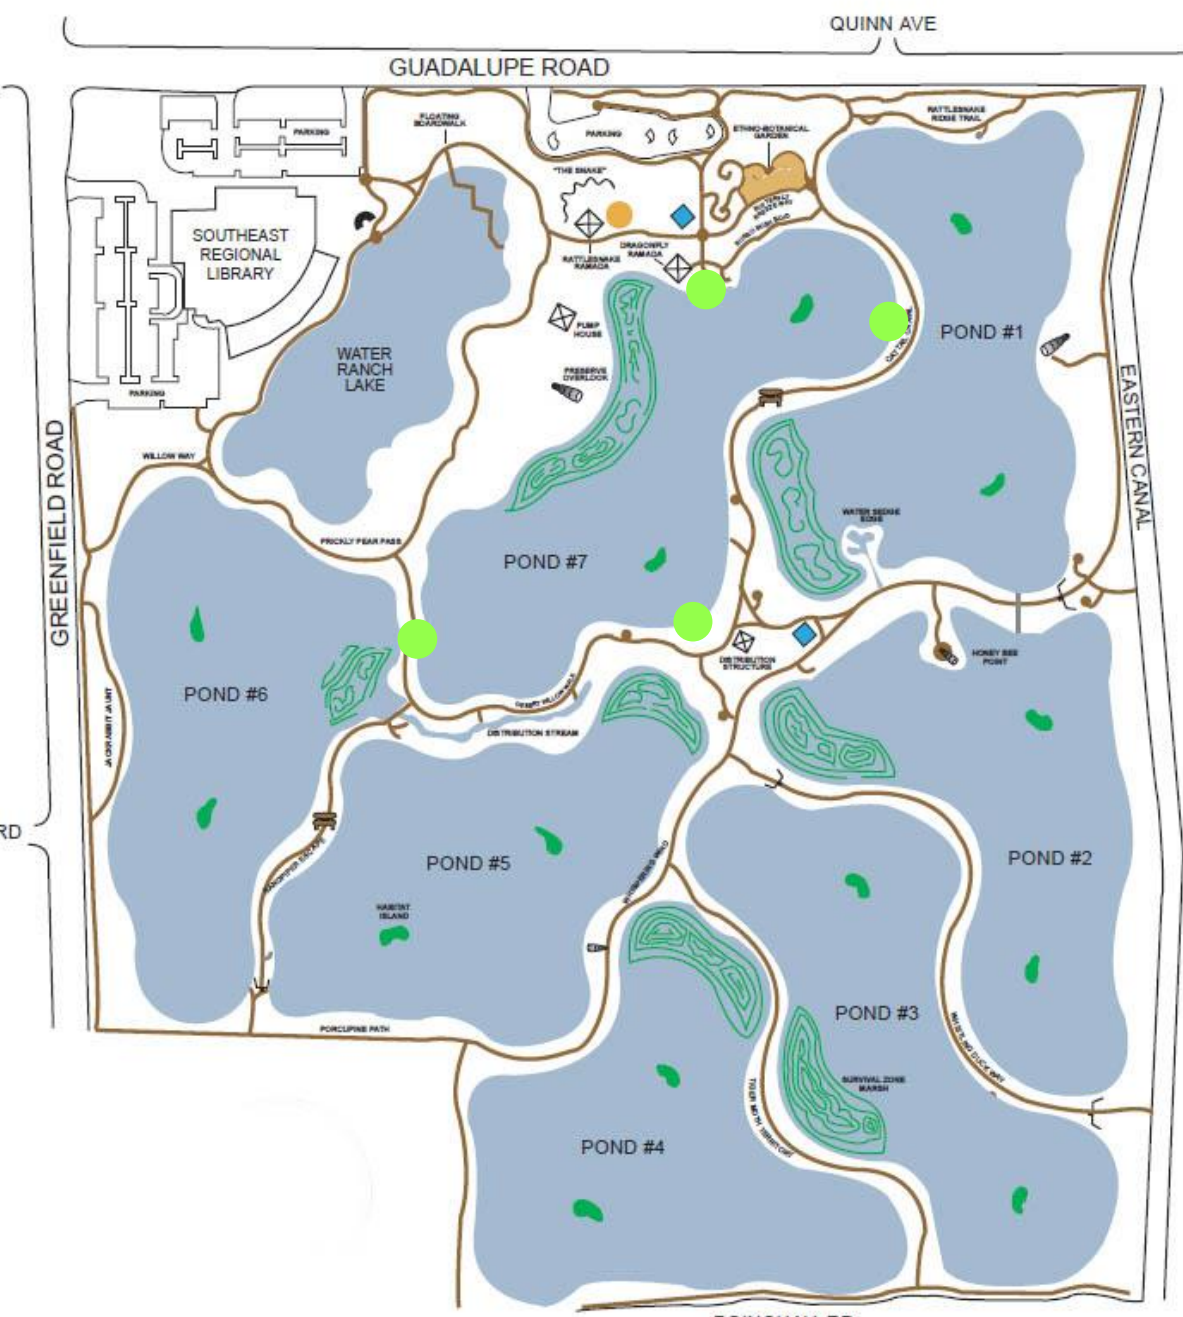
Fig. 2 Map of Gilbert Riparian Preserve

Legend:
● Pond 7 Sampling Locations

1. Collect 2 wastewater effluent samples from splitter box
2. Collect 1 water sample from 4 locations around pond 7 (see map)
3. Repeat 3 times a week for 3 weeks
4. Send samples to ASU METALS facility for the following analyses
 - i. Nitrate + Nitrite
 - ii. Orthophosphate
 - iii. Total Nitrogen
 - iv. Total Phosphorus
5. Test samples for chlorophyll content using spectrophotometry

- Collect soil samples from the center of pond 7 radiating out to the 4 water sampling locations at lease once
