Quantifying Mechanical Failure in Perovskite Semiconductors Using Shear Testing

Emily Carrillo Munoz, Aerospace Engineering

Mentor: Dr. Nicholas Rolston, Assistant Professor

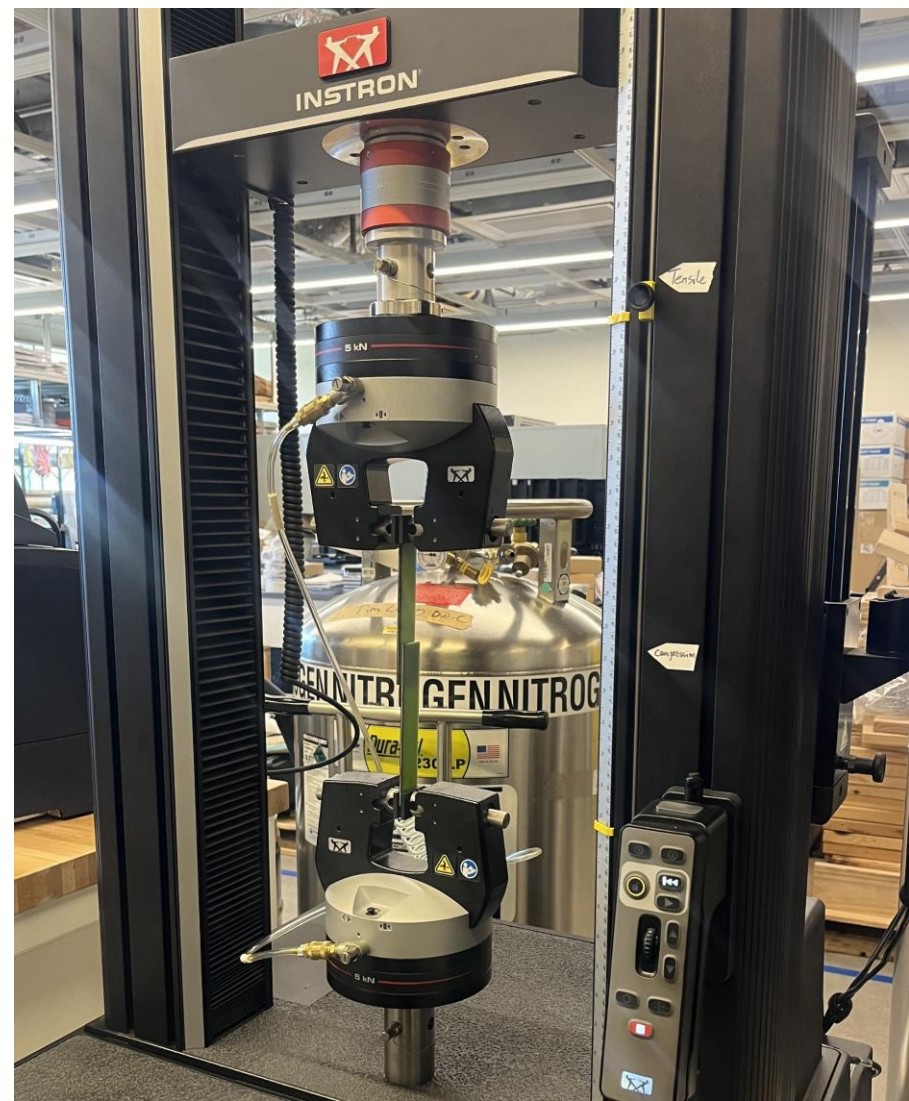
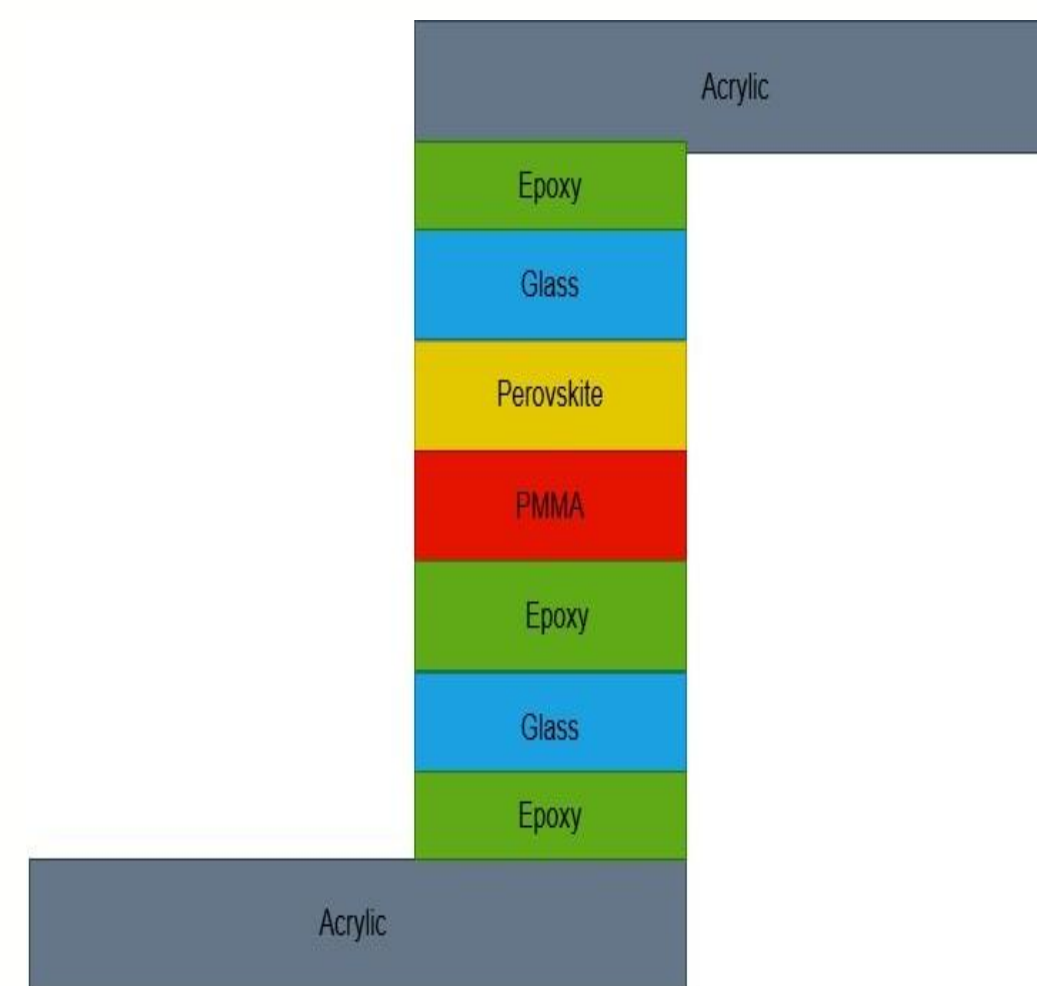
Mode II (Shear) is when surfaces slide over one another [2]. Shear strength is the amount of force applied before a material delaminates. This is the primary cause of edge debonding, where the film separates at the edges [1]. Metal halide perovskites are promising for solar cells due to their high efficiency and low-cost fabrication. However, they are limited by mechanical fragility and poor interfacial adhesion, which leads to delamination. This research characterizes Mode II sliding properties to understand the mechanical stability of the perovskite-glass interface.

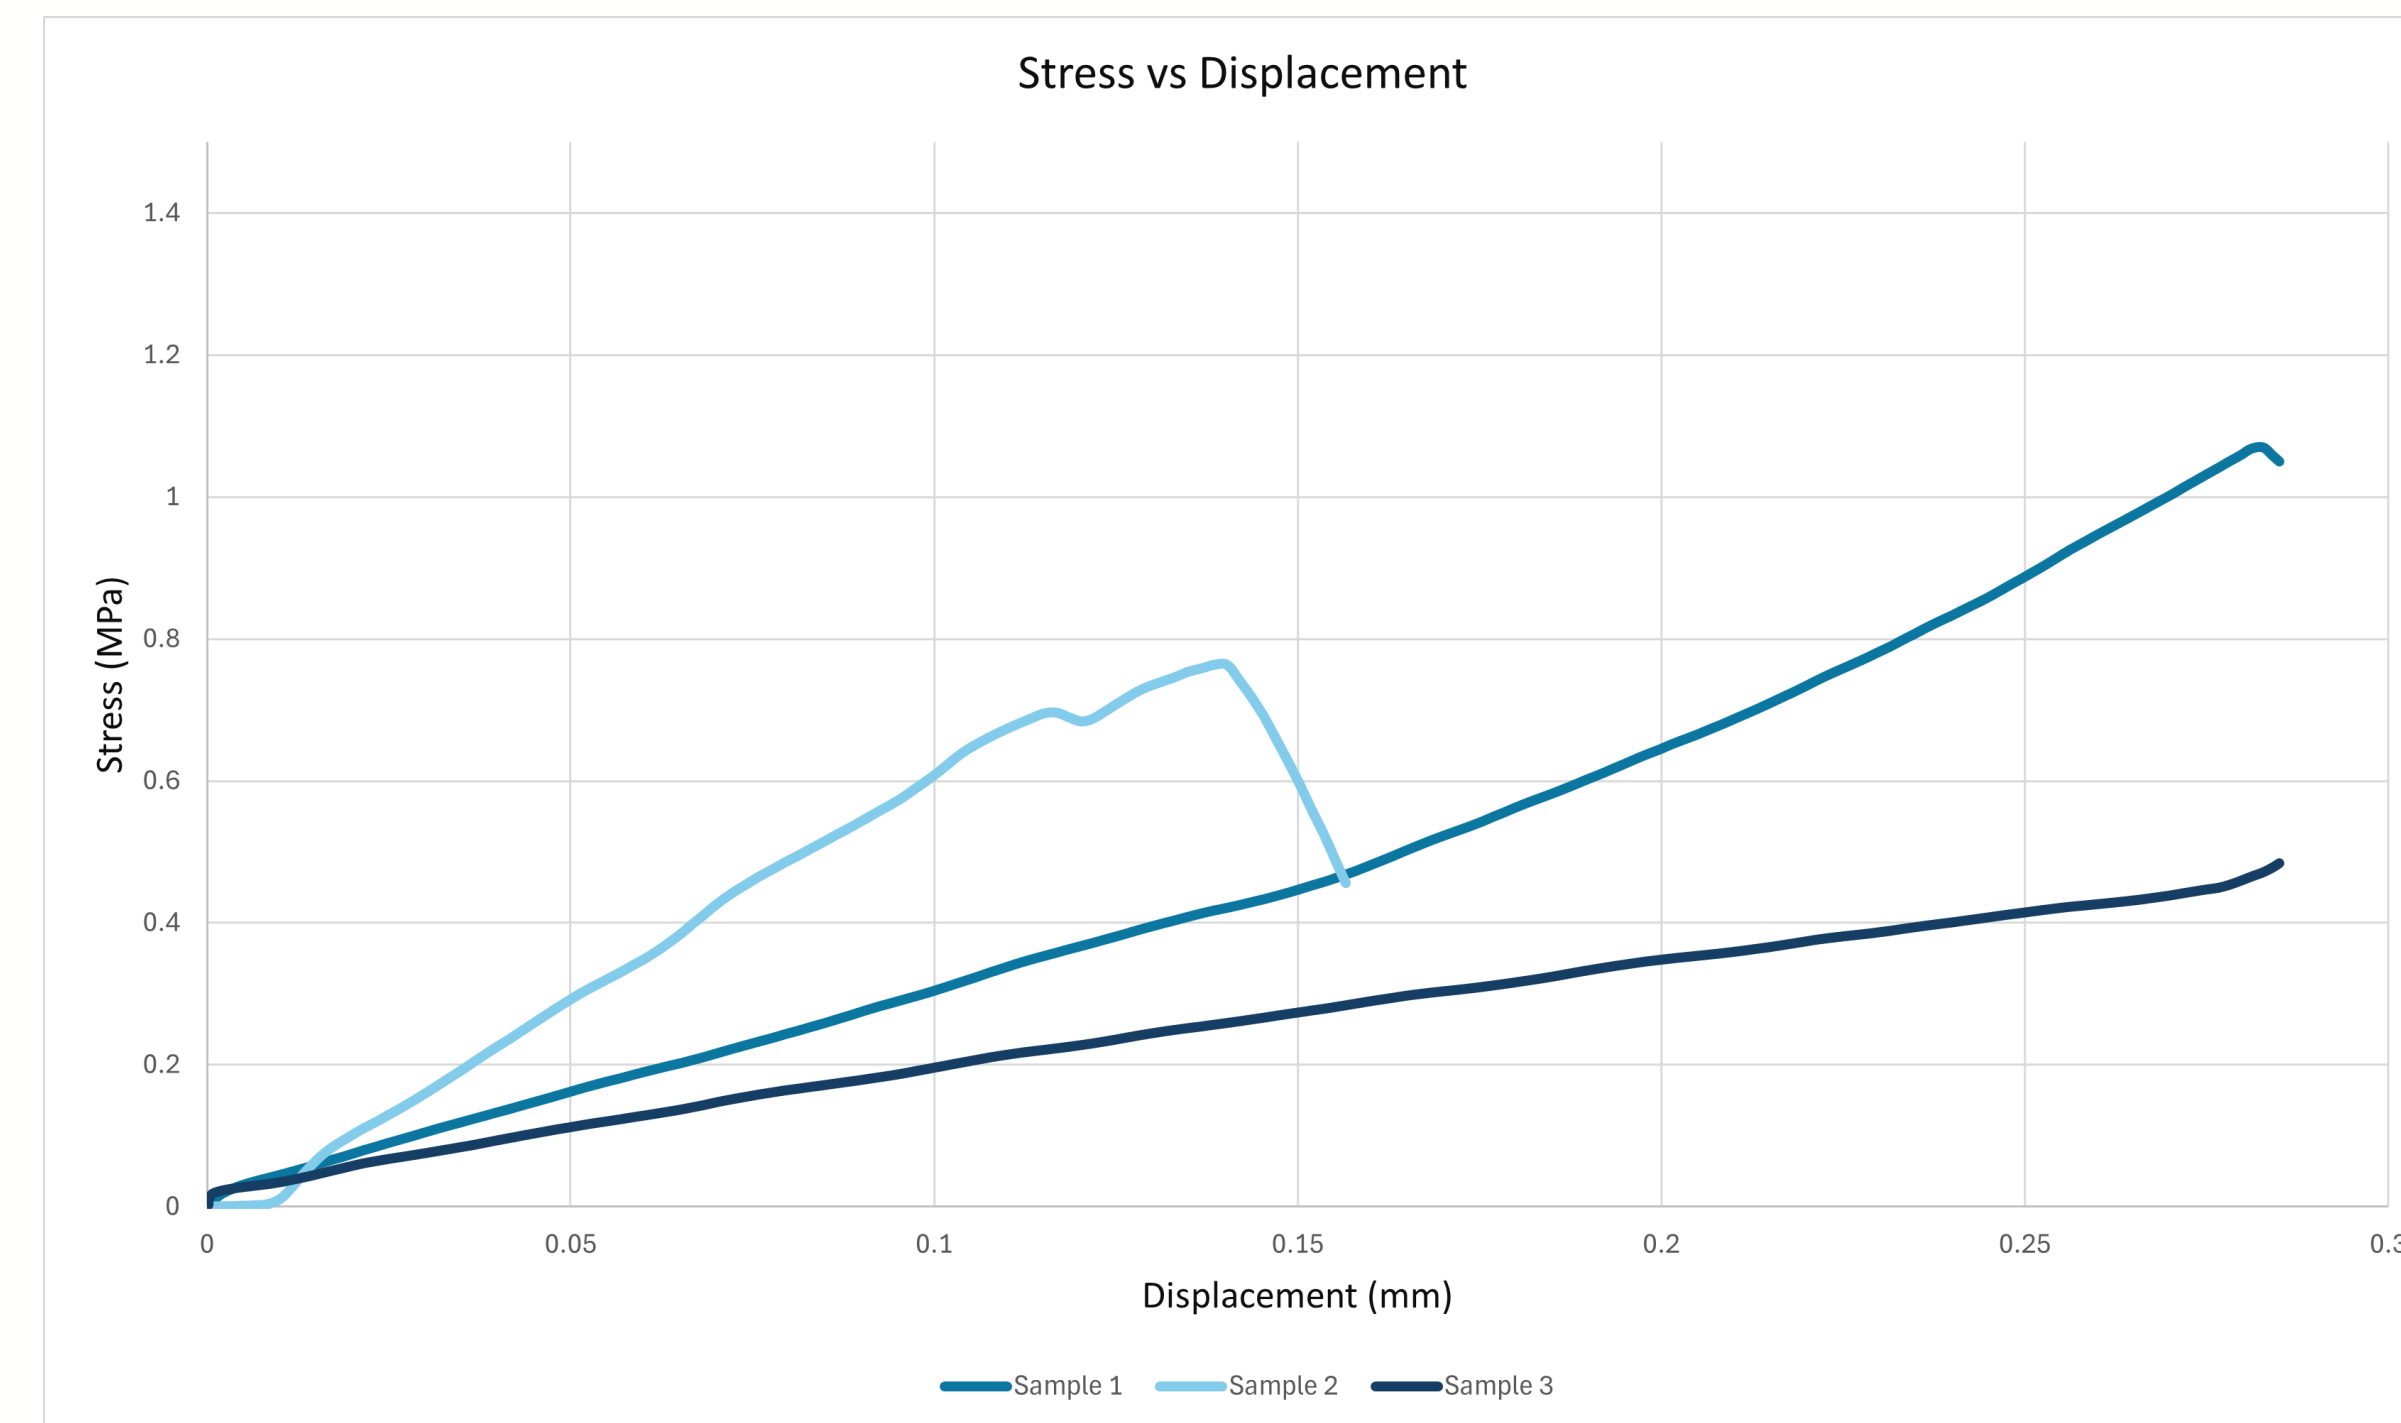
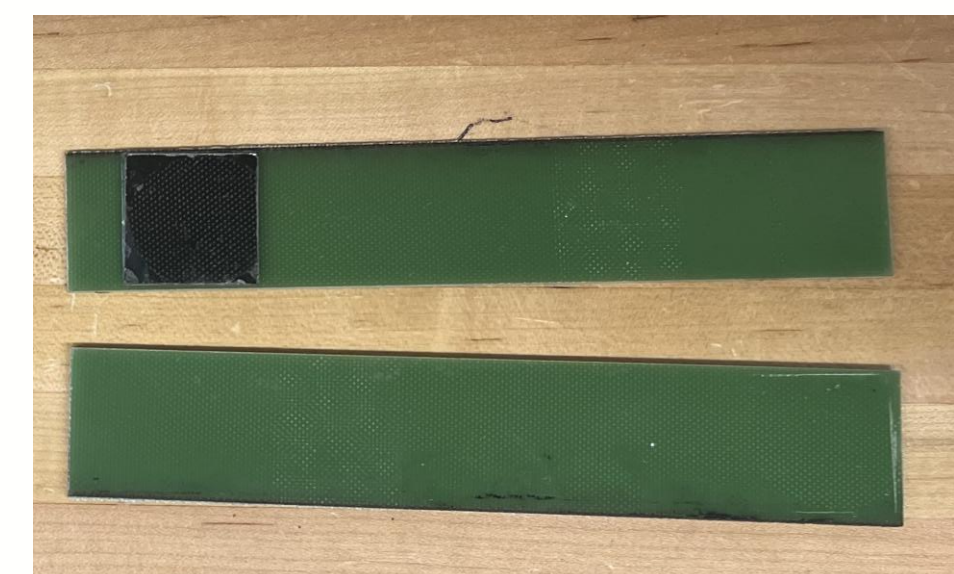
Sample 1: Adhesion failure at glass/epoxy interface (higher surface roughness)

This is a sample after fracturing occurred. The two sides of the sample have separated on the acrylic/epoxy/glass layer due to the bond between acrylic/glass being weaker than the bond of the perovskite on glass. The perovskite has a shear strength greater than the value measured and did not delaminate.

Initial testing had significant optimization of sample configuration. The early designs lacked proper gripping supports, poor adhesion/premature failure, and weak configurations. The final configuration (glass/perovskite/PMMA/epoxy/glass) with acrylic handles bonded allowed for shear testing to be performed and showed that the bond between acrylic and glass was weaker than of the perovskite.
