# Machine Learning-Guided Optimization of Perovskite Films Using In-Situ Imaging

Zareen Tasnim Rahman, Electrical Engineering  
Mentor: Nicholas Rolston, Assistant Professor  
School of Electrical, Computer and Energy Engineering

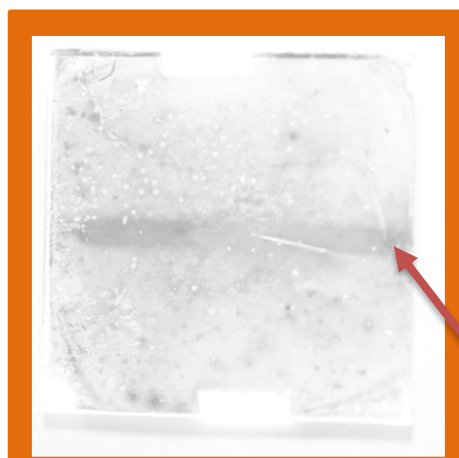
(1) G-PVR-C60-Ag-B

Standard Image

PL image

**Note:** In (1) and (2), the lower PL intensity under the busbar suggests efficient charge extraction and good interfacial contact, with no strong evidence of delamination; the reduced signal is likely due to effective extraction or minor localized degradation. In contrast, (3) and (4) show higher PL intensity, indicating poorer charge transfer at the interface, possibly due to weaker contact or partial delamination, leading to charge accumulation and increased radiative recombination.
